FLIGHT MEASUREMENTS OF THE DIRECTIONAL STABILITY AND CONTROL
OF A P-51D AIRPLANE WITH A HORN-BALANCED RUDDER AS
COMPARED WITH PREVIOUSLY TESTED VERTICAL-TAIL CONFIGURATIONS

December 3, 1946

NACA RM No. L6J25

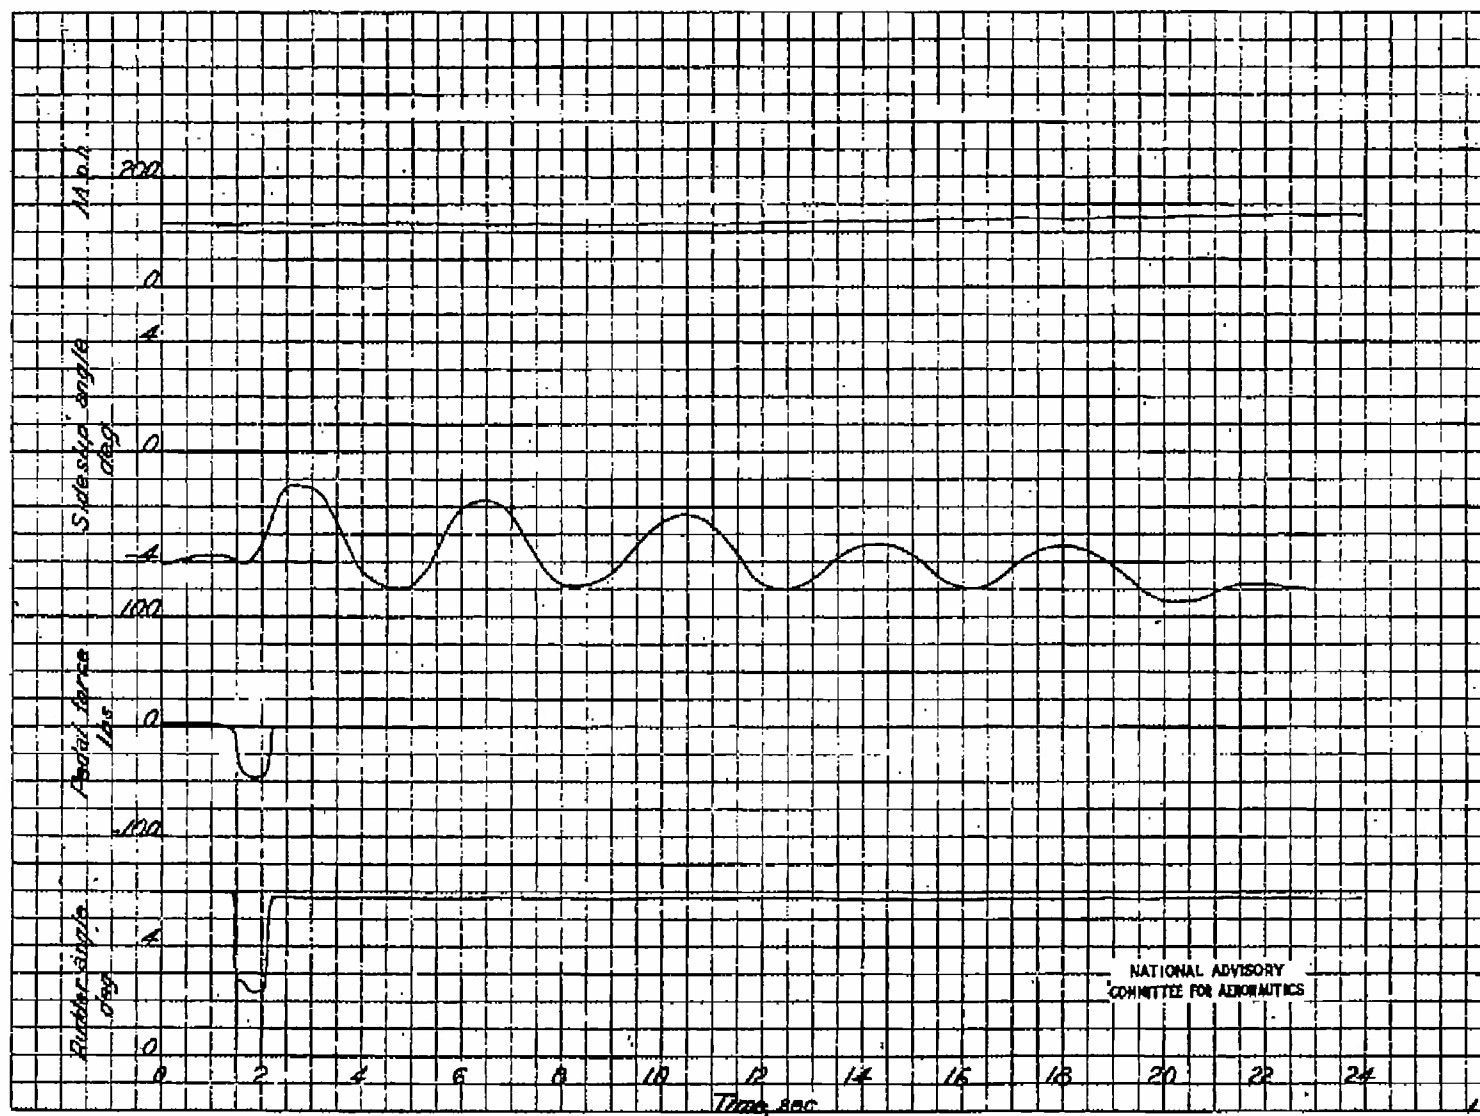
Figure 18.- Rudder kick to left at 25,000 feet altitude, climbing condition $V_{1S} = 130$ miles per hour.
P-51D-20-NA airplane with horn balanced rudder.

Lateral oscillations were made at high and low altitude by deflecting the rudder at a rapid rate and releasing it. These tests were made at altitudes of 10,000 and 25,000 feet and at speeds of 130, 150, 250, and 350 miles per hour. The records showed that the oscillations damped satisfactorily in all runs except those at 130 miles per hour. A time history of a typical oscillation is shown in figure 17. The rudder returned rapidly to its trim position when released and remained there during the oscillations. An undamped lateral oscillation occurred at an indicated airspeed of 130 miles per hour at 25,000 feet altitude. Figures 18 and 19 show time histories of the undamped oscillations. The undamped lateral oscillation was accompanied by a spiral divergence and an increase in the indicated airspeed. When the speed increased the oscillations damped rapidly. There was no tendency for a snaking oscillation, in which the rudder motion reinforces the motion of the airplane. The rudder position record showed that the rudder remained essentially fixed during the oscillation, so that the lack of damping cannot be attributed to the characteristics of the horn-balanced rudder.

This type of oscillation, which has been observed on other high-powered single-engine airplane, involves a combination of lateral and longitudinal oscillations, and is believed to be caused by the gyroscopic effect of the propeller. The pilot did not consider this undamped oscillation to be objectionable because it was easily controlled.
